CALSPAN ON-SITE AIR BAG DEPLOYMENT INVESTIGATION

CALSPAN CASE NO. 91-12

FLEET - 1990 DODGE SHADOW

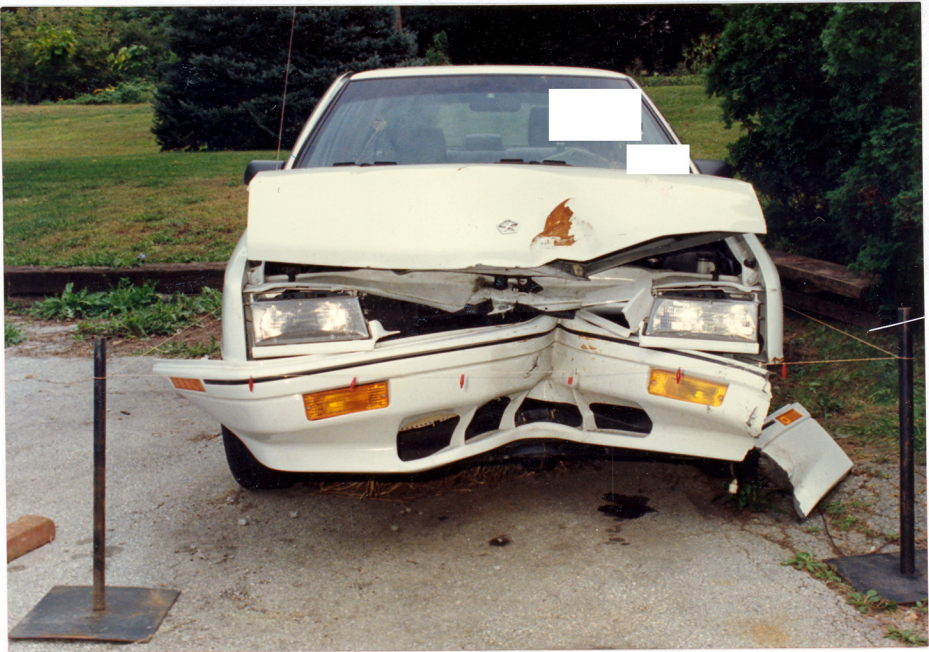
8

The center frontal area of the Dodge Shadow impacted the 10" diameter utility pole which resulted in moderate damage to the vehicle. Maximum crush was 14.5" located on the bumper reinforcement bar 4.75" left of center. Direct contact damage on the bumper facia began 26.25" inboard of the right corner and extended 8.75" to the left. The impact deformed the entire width of the front bumper reinforcement bar resulting in a combined induced and direct contact damage length (Field L) of 48.0". Crush values at bumper level were as follows: $C_1=0.25"$, $C_2=5.75"$, $C_3=13.25"$, $C_4=7.4"$, $C_5=2.25"$, $C_6=0.0"$.

Frontal Damage To The Dodge Shadow.

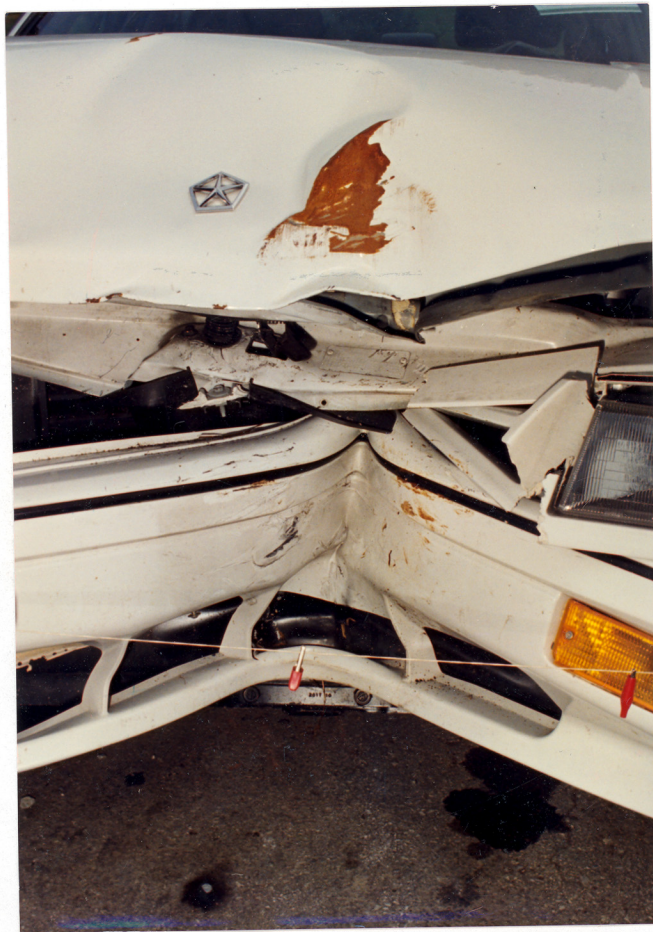
9

Closeup View Of The Center Frontal Utility Pole Impact Damage.

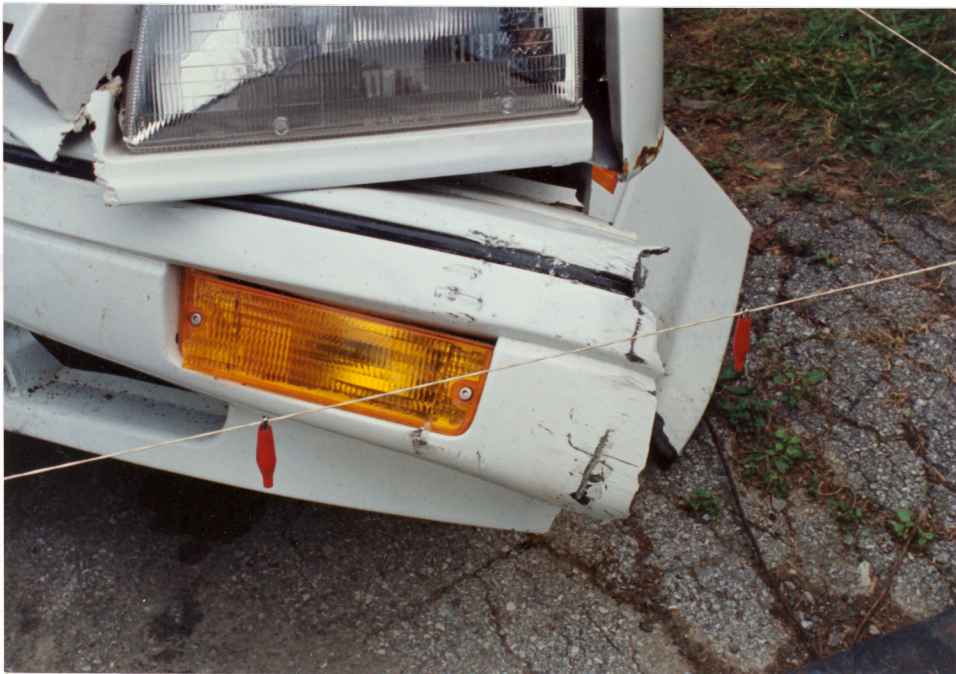
11

The vehicle continued forward and impacted a second concrete fence post with the left corner area of the front bumper. Direct contact damage began at the bumper corner and extended 5" inboard onto the bumper facia. The concrete post impacts separated the left corner wrap-around of the bumper facia. The extent of bumper crush was minimal, but unknown due to the bumper displacement from the utility pole impact.

Closeup View Of The Second Fence Post Impact Damage To The
Left Bumper Corner Area.

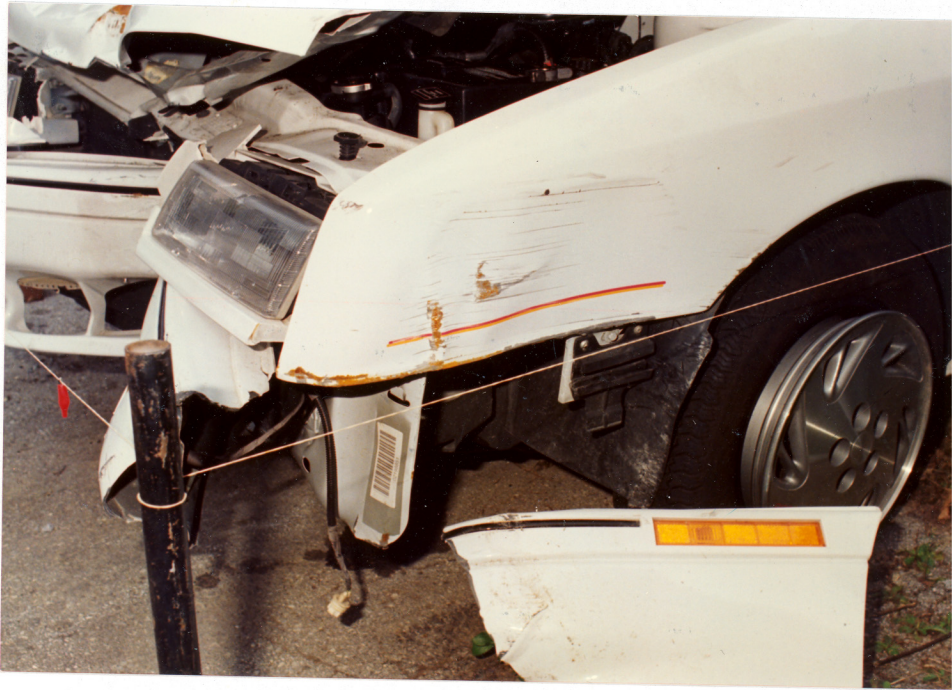
12

The left front corner area of the vehicle initially side-swiped the first fence post that was located 8'2" south of the south road edge. Damage to the vehicle was minimal which involved a shallow dent to the front third of the left front fender with paint abrasions. The damage extended 23.75" rearward on the fender before ending at a point 7.75" forward of the left front axle. The left front tire probably impacted the fence post which resulted in an airout of the tire. There was no visible damage to the tire or alloy wheel.

Fence Post Sideswipe Damage To The Left Front Fender Area.

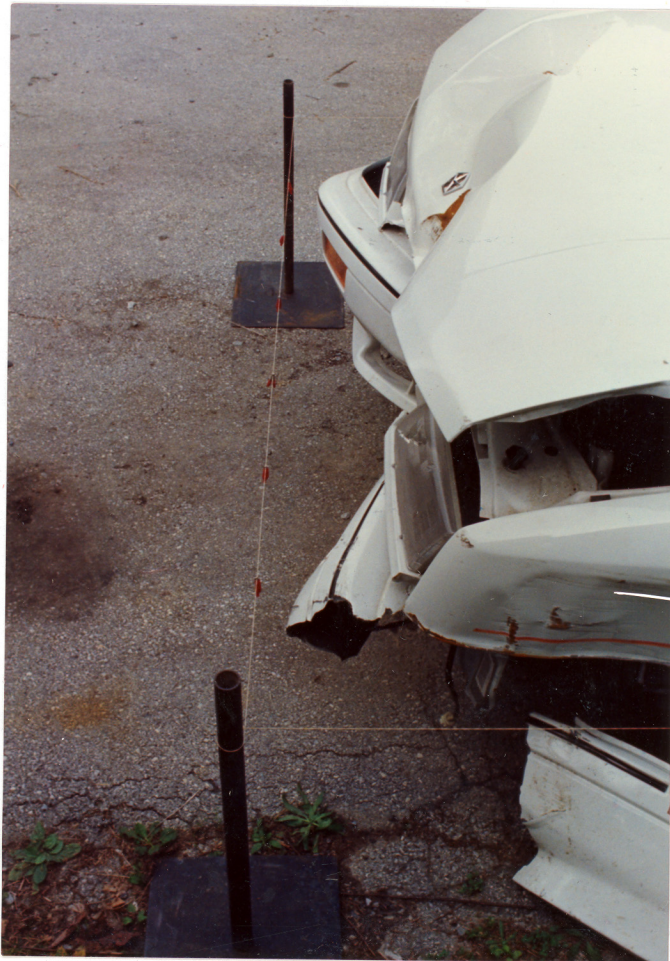
13

Left Perpendicular View Of The Frontal Area Showing
The Extent Of Bumper Crush.

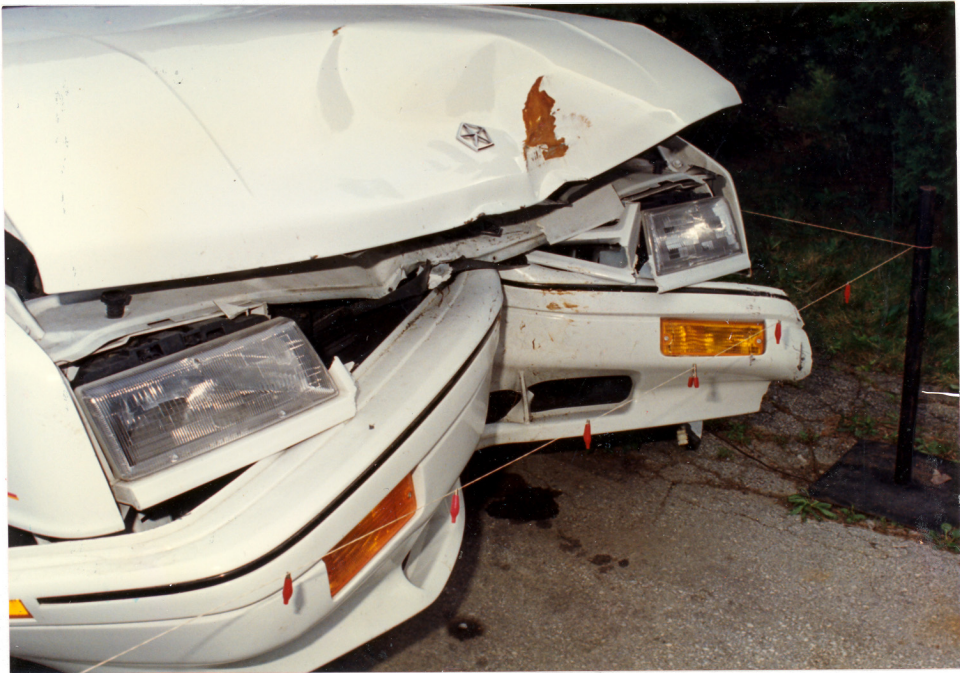
17

Angular View Of The Utility Pole Impact Damage.

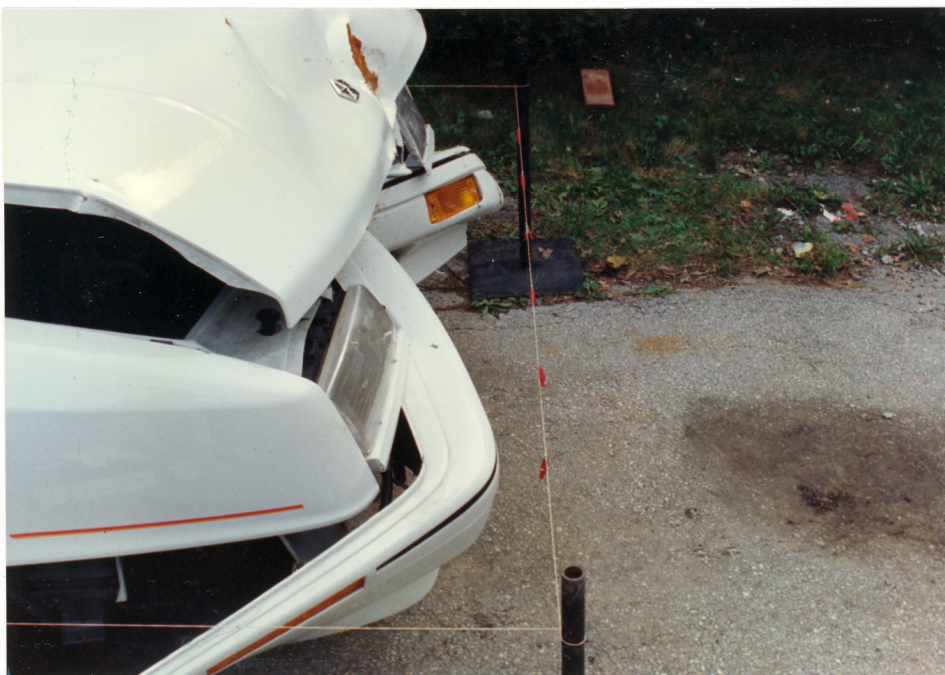
18

Perpendicular View From The Right Corner Showing The Extent of Frontal Crush.

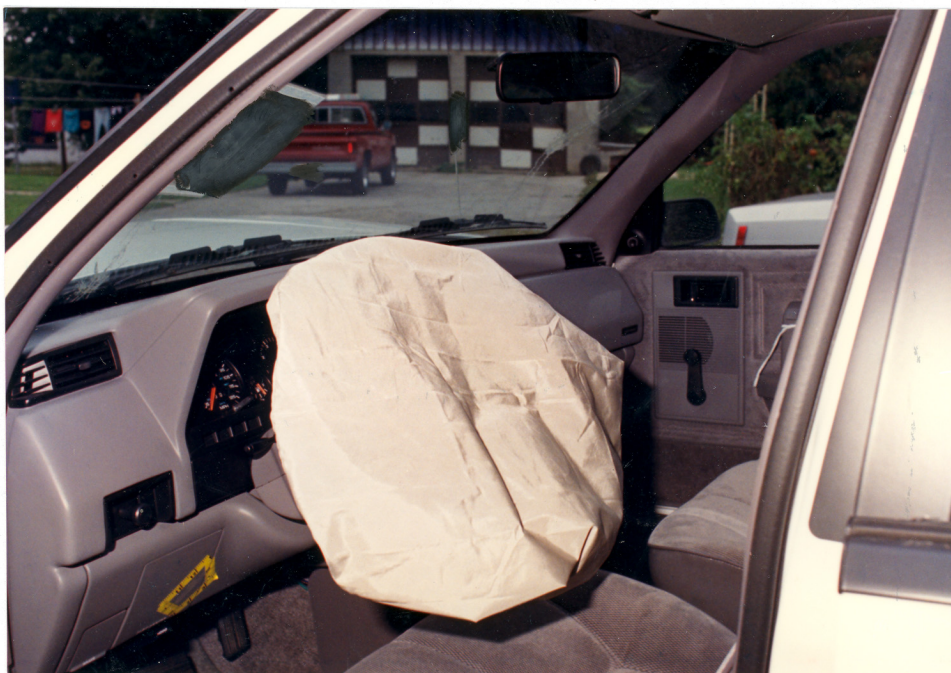
19

Overall Interior View Of The Driver's Contact Point And Deployed Air Bag.

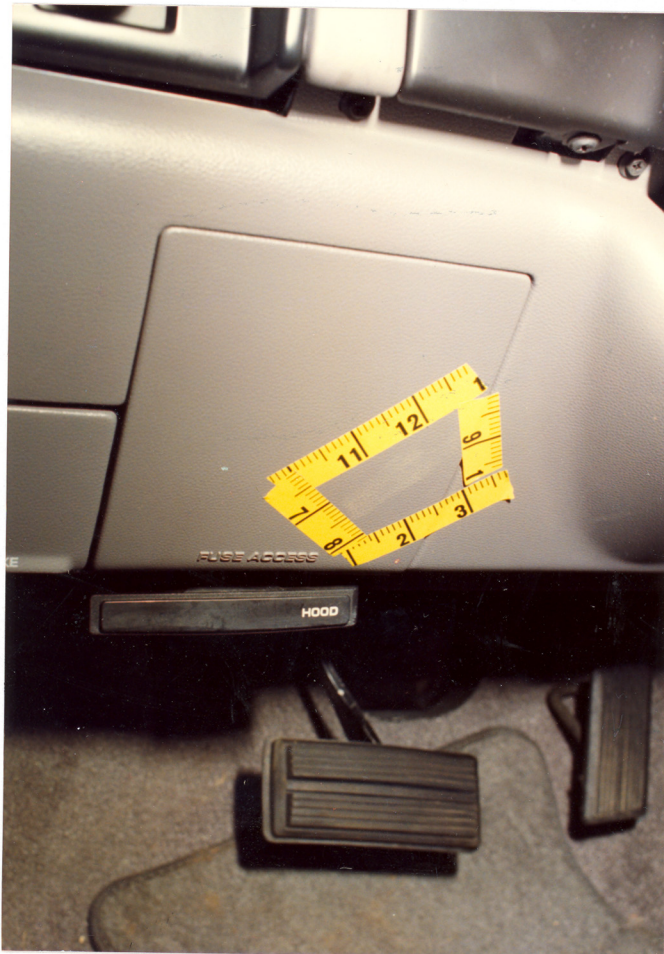
21

The driver's knees contacted the rigid knee bolster which resulted in injury to both knees; however, only the left knee produced contact evidence. A nylon stocking transfer was noted to the fuse box cover 17.75-19.75" left of center and 15-17" below the upper instrument panel.

Left Knee Nylon Stocking Transfer To The Fuse Box Cover In The Knee Bolster.

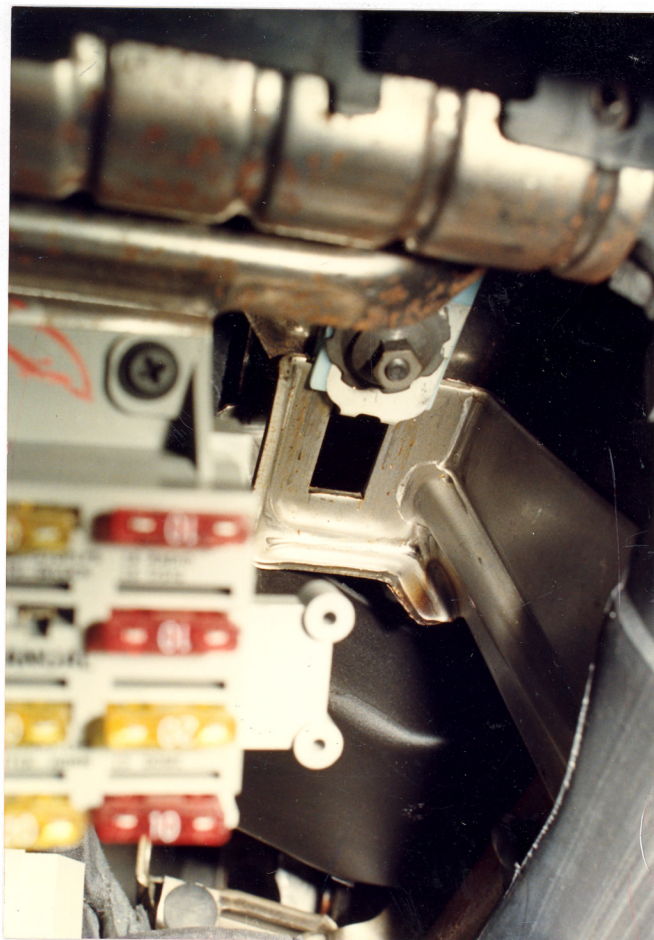
24

Left Steering Column Shear Capsule, 1.375" of Compression.

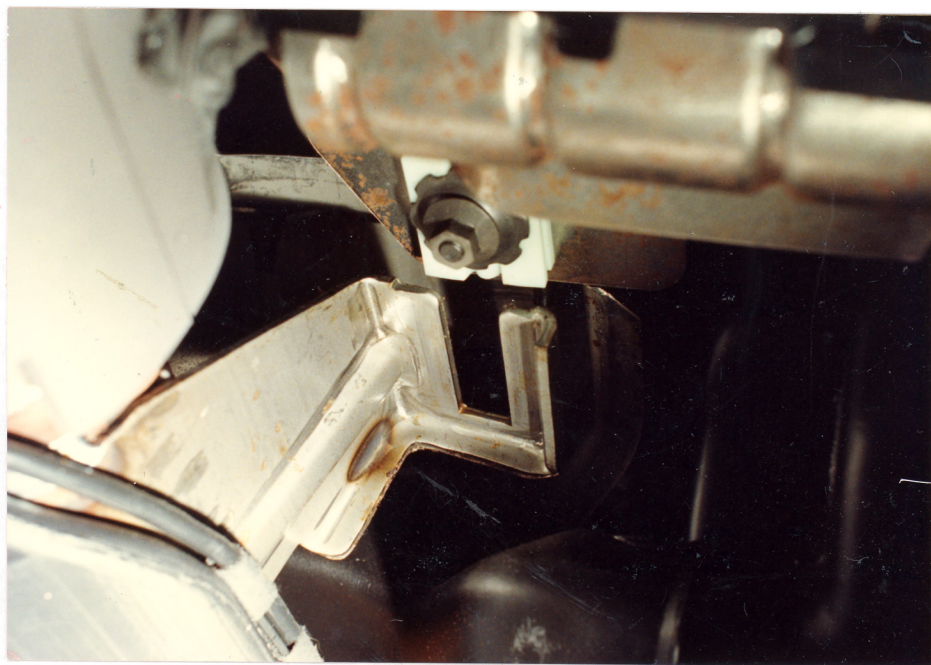
25

Right Steering Column Shear Capsule, 1.625" of Compression.

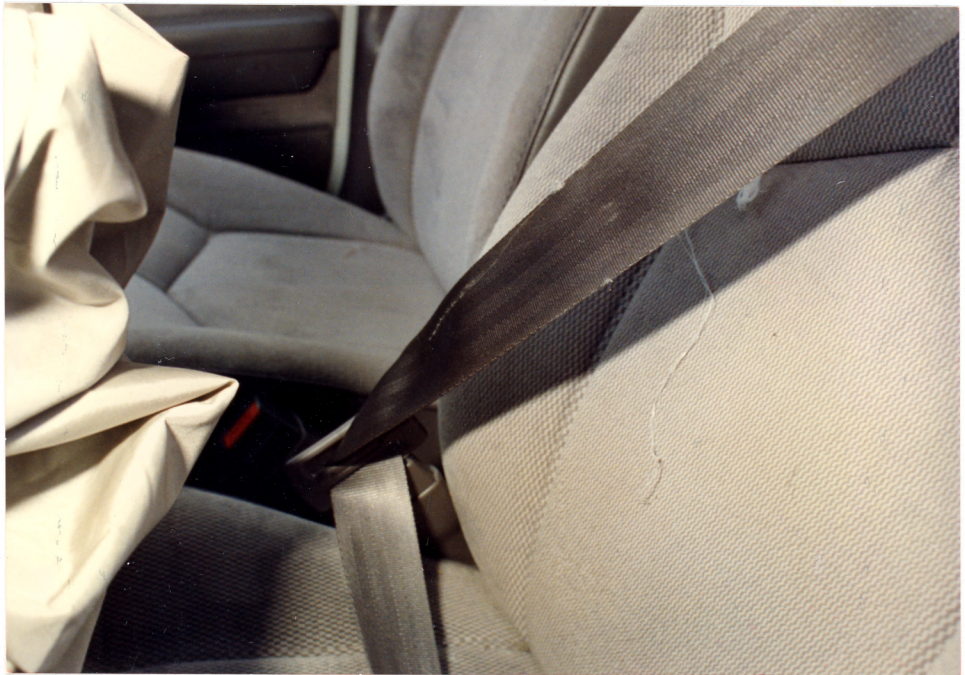
27

Snags On Outside Surface Of Belt Webbing.

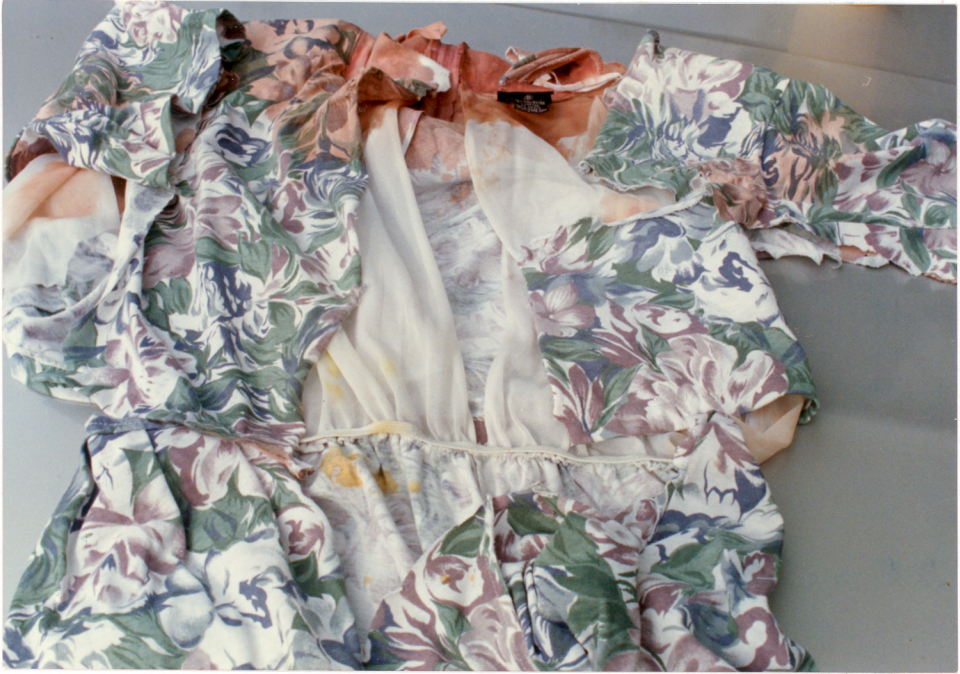
30

Vertical Tear To The Top Of The Dress.

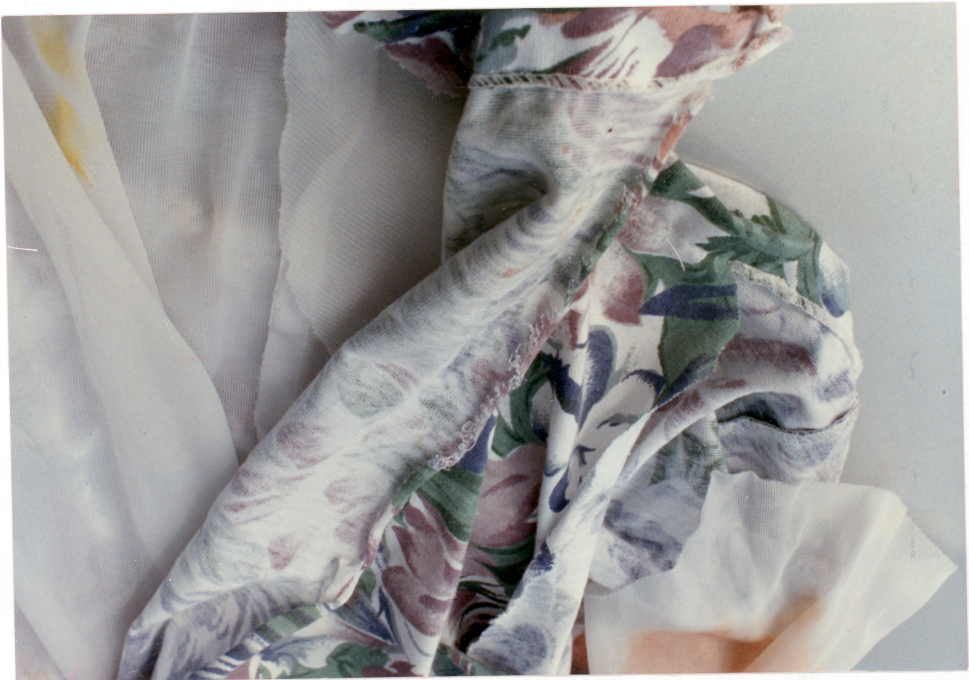
31

Torn Right Side Of Dress.

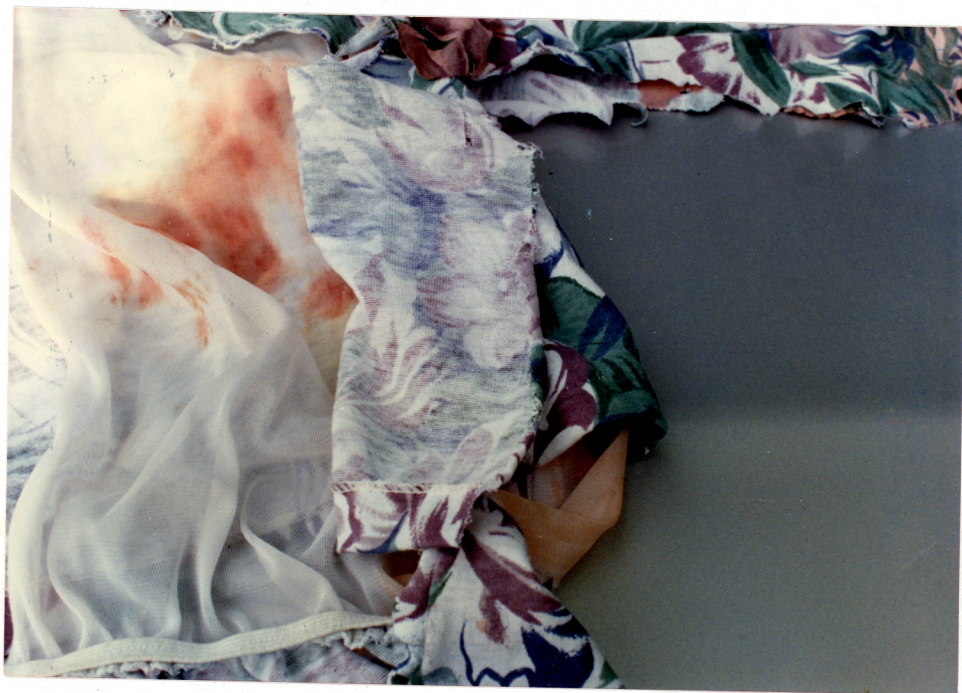
Torn Left Side Of Dress.

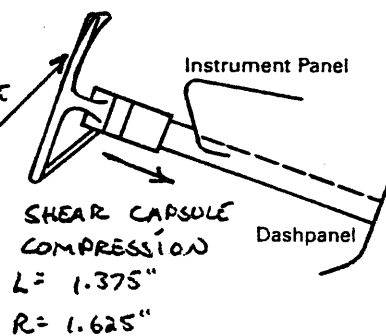
~.25" OF
UPPER RIM
DISPLACEMENT

THORACIC/AIR BAG
BENDING OF UPPER RIM

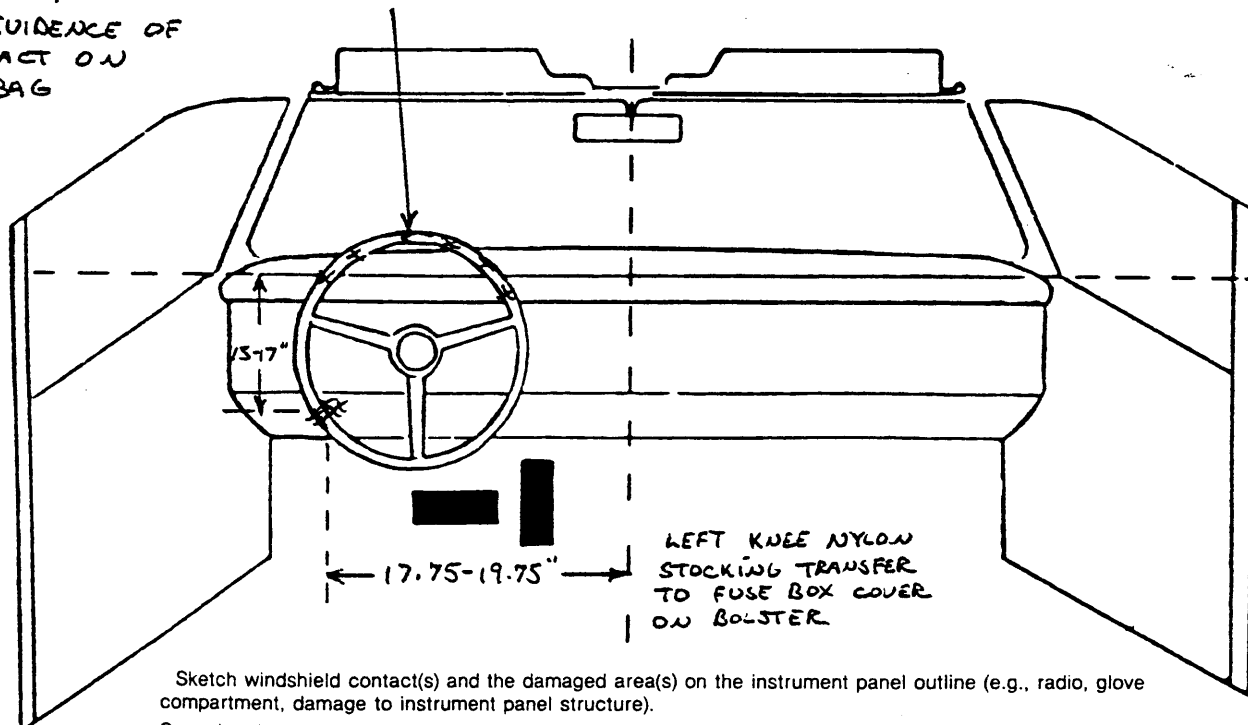
NO EVIDENCE OF
CONTACT ON
AIR BAG

LEFT KNEE NYLON
STOCKING TRANSFER
TO FUSE BOX COVER
ON BOLSTER
